PART 1 OF 3

Mechanics and Materials Practice

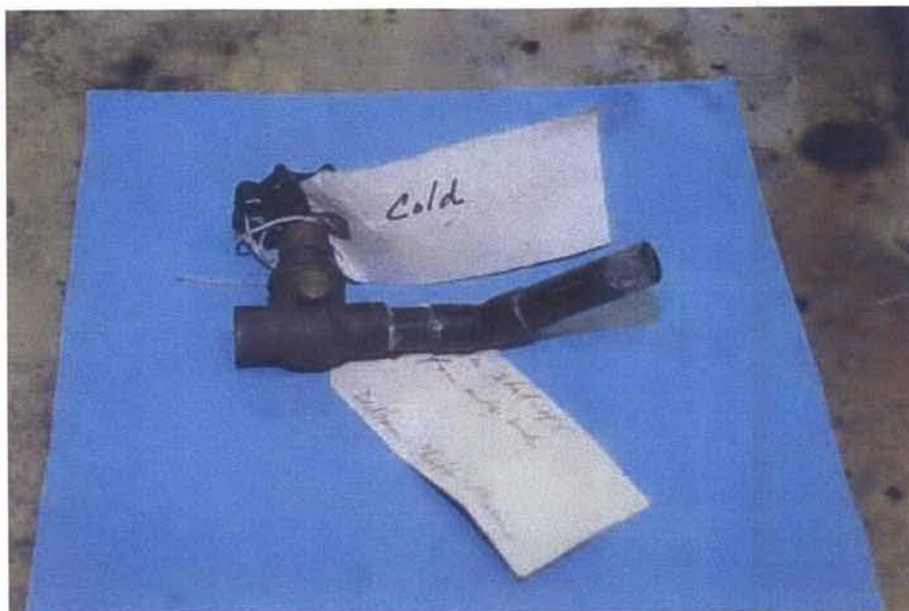
Figure 1. Photograph of the detached valve and connected copper tube. A photograph of the corresponding male fitting is shown in Figure 3 and the corresponding female fitting is shown in Figure 4.
